Report No. CG-D-05-94

AIRCRAFT CORROSION STUDY

J.T. Stropki
and
R.D. Smith

FINAL REPORT
December 1993

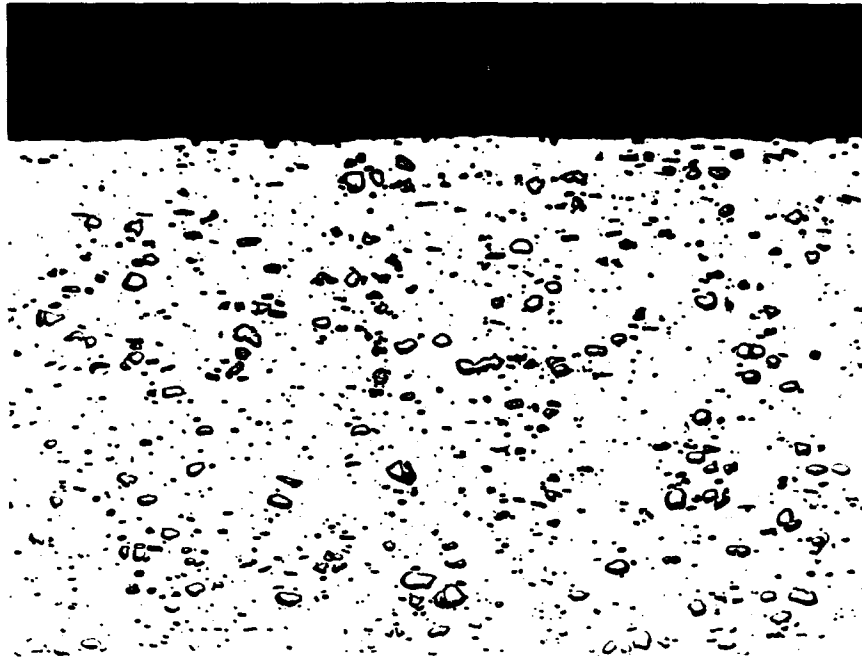
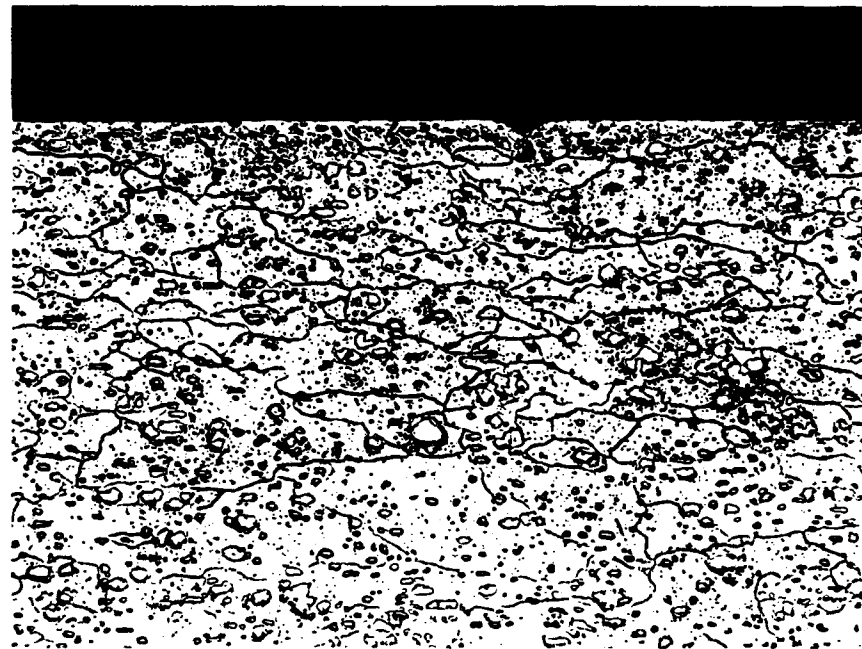
As shown in Figure 3, the microstructure for sample No. 3 (Alloy 2219-0) contained a large number of coarse intermetallic compounds. These compounds were uniformly dispersed throughout the individual grains of this alloy; that distribution contributes to this material's resistance to degradation by elevated temperatures. As expected from a comparison of mechanical properties, the average microhardness measured for this particular material was significantly lower than measurements obtained for the 2024-T3 and French alloys.

Figure 3. Photomicrographs documenting the microstructure of Specimen No. 3, Alloy 2219-O (bare).

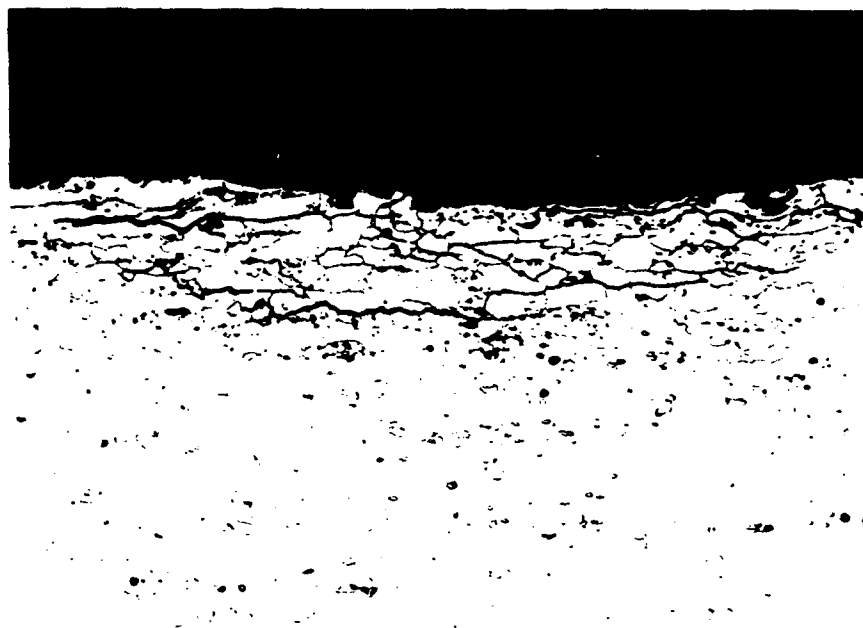
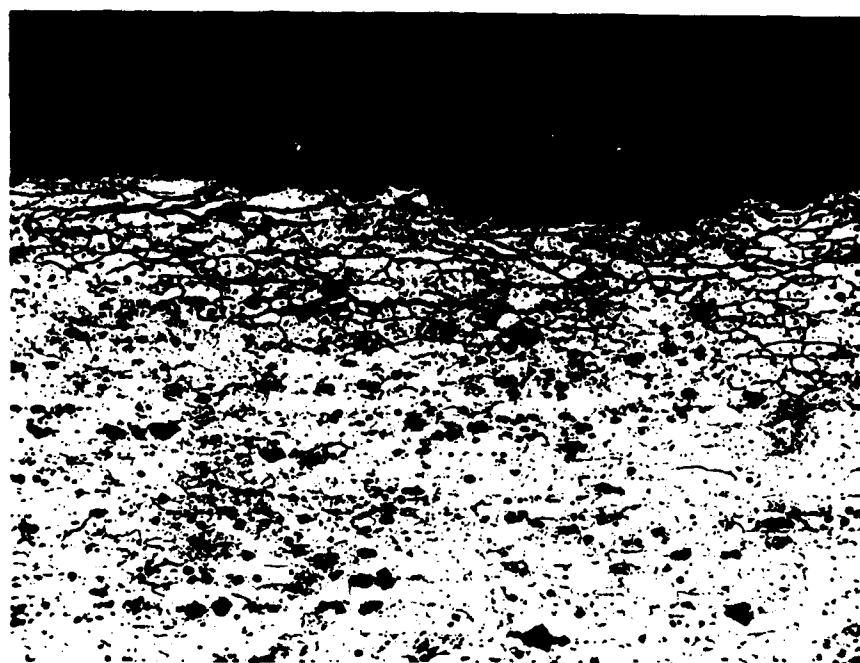
The microstructure of an "aged" French alloy that was removed from a wing slat of an HU-25A Falcon jet aircraft is provided in Figures 4a and 4b. Intergranular and exfoliation corrosion was evident along the internal surface of the sample. Metallographic examinations confirmed that the attack was concentrated beneath a primer coating applied to the internal surface of the wing slat. Battelle's ability to determine if the attack was induced as a

Figure 4. Photomicrographs documenting the microstructure of Specimen No. 4, the French alloy (primed).

result of (1) elevated temperatures (during antiicing of slat), (2) atmospheric corrosion, or (3) both, prior to being primed, was limited by a lack of service history on this particular component. No attack was noted along the external surfaces of the sample. As shown in Table 1, the average Knoop microhardness of this material was 153.

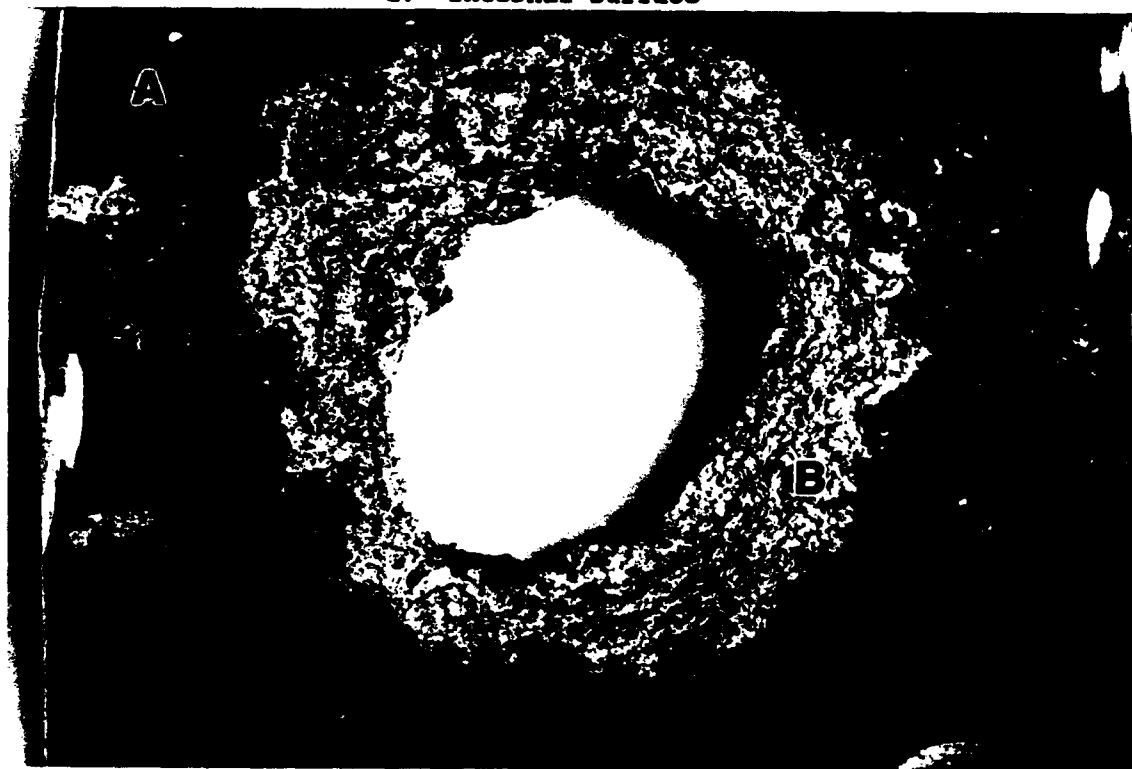
Photographs documenting the size and extent of corrosion attack on both the internal and external surfaces of the damaged wing slat sample are provided in Figure 6. The external surfaces of the "as-received" sample were analyzed using a stereomicroscope and scanning electron microscope (SEM). Energy Dispersive Spectroscopic analysis of x-rays (EDS) techniques were used to determine the semi-quantitative composition of the deposits contained within three distinct areas of the corroded sample. Those areas included one in a noncorroded region (Region A in Figure 6b), shown at higher magnification in Figure 7, and two within the corroded region surrounding the hole (Region B in Figure 6b), shown in higher magnification in Figure 8. The results of the EDS analyses are presented in Table 4.

Figure 6. Photographs documenting the extent of damage noted on the internal and external surfaces of a wing slat sample removed from an HU-25A aircraft.

The concentration of all elements except sulfur and chlorine are low within the corroded sections of the wing slat sample. The presence of these elements on a susceptible aluminum material accelerates localized corrosion, as demonstrated by the magnitude of damage noted on the sample shown in Figure 6.

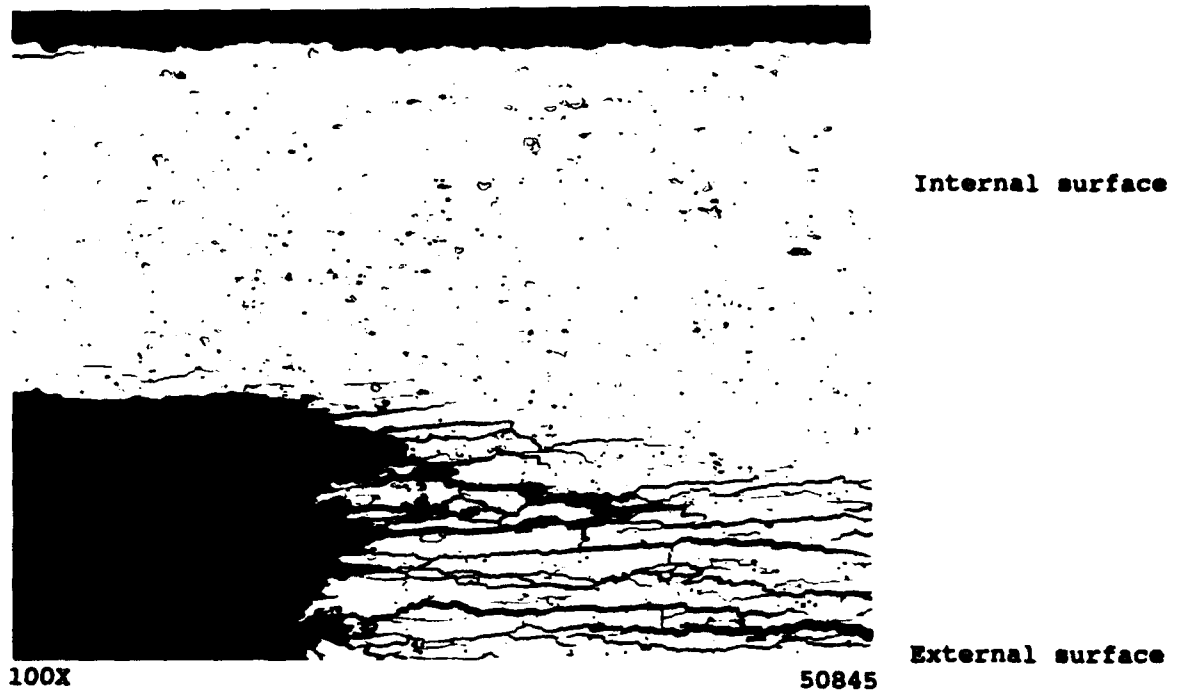
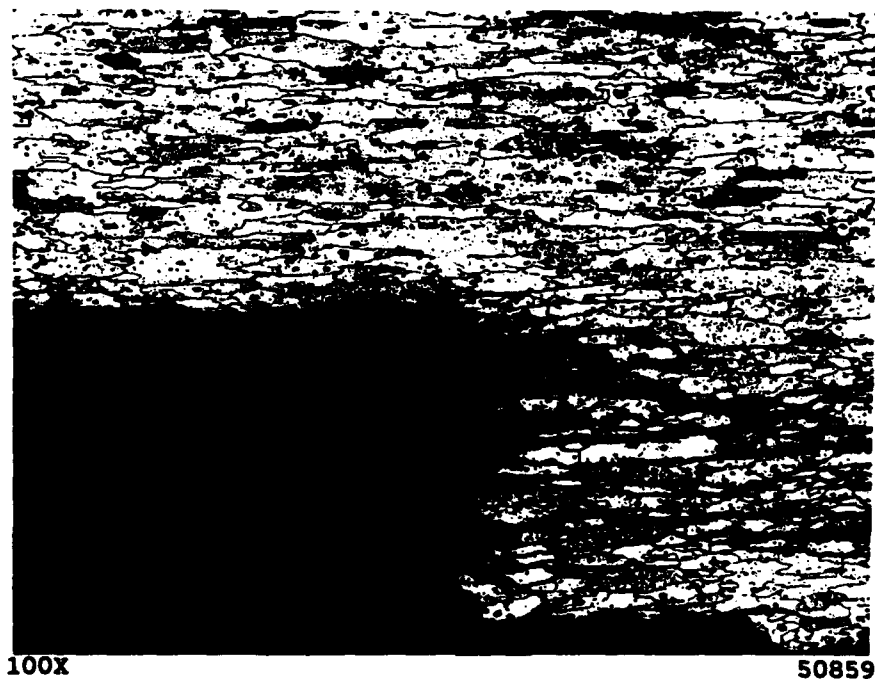
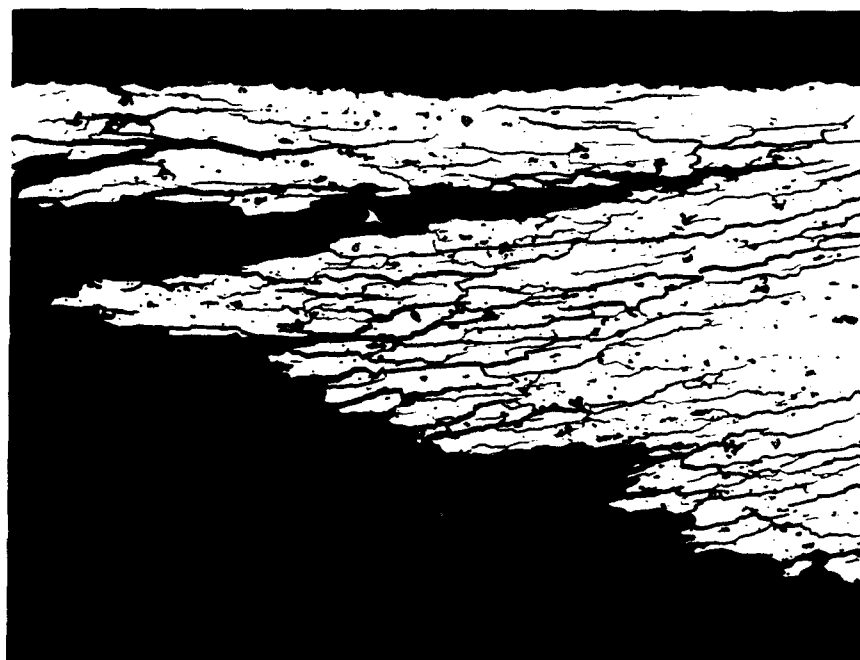
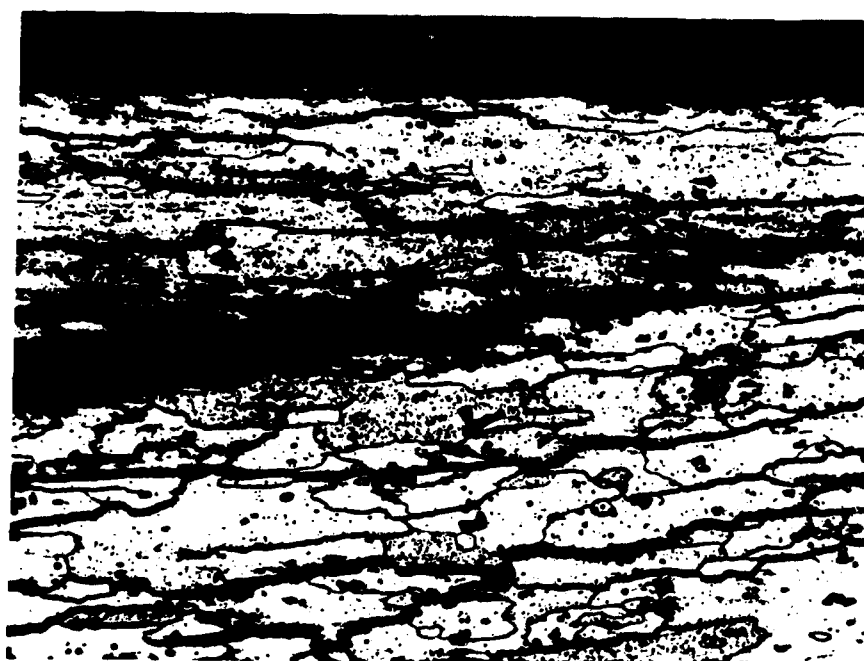
Additional processing of the damaged wing slat sample included mounting the entire sample in an epoxy material and selectively cutting the sample into four separate sections. Each section was then metallographically polished and etched for an examination of the sample's microstructure. Photomicrographs documenting the "as-polished" and "as-etched" condition of the alloy in two representative sections of the sample are shown in Figures 9a through 9d. An examination of each photomicrograph confirms the presence of severe intergranular and exfoliation corrosion. These failure modes are characteristic of the high strength aluminum materials, especially if the materials are overheated (retempered) and exposed to corrosive contaminants such as sulfates and chlorides.

Figure 9. Photomicrographs documenting the intergranular and exfoliation corrosion attack noted in two separate metallographic cross-sections taken through two areas of the damaged wing slat sample.
